Canadian Forces Experience with Turbofan HCF – Case Study

High Cycle Fatigue (HCF) cracking of a Canadian Forces (CF) turbofan engine fuel tube resulted in a six year, multinational effort to identify the root cause and to ultimately develop and implement a solution. The second of three fuel tube failures experienced by the CF during this timeframe resulted in an engine fire that caused significant damage to a military aircraft, underlining the seriousness of the issue at hand. With HCF identified as the mechanism of failure, efforts focused on vibration input to the fuel tube during engine operation. An experiment was developed to instrument an in-service fuel tube and perform comprehensive flight tests to quantify the strains experienced by the tube and identify vibration frequencies that required mitigation in order to eliminate HCF failures. A damper bracket was developed to shift the modal response of the fuel tube away from damaging frequencies experienced in-flight. The prototype bracket then required the addition of an adjustable feature that would allow it to accommodate slight variability in the location of mounting points from engine to engine. In addition, modification

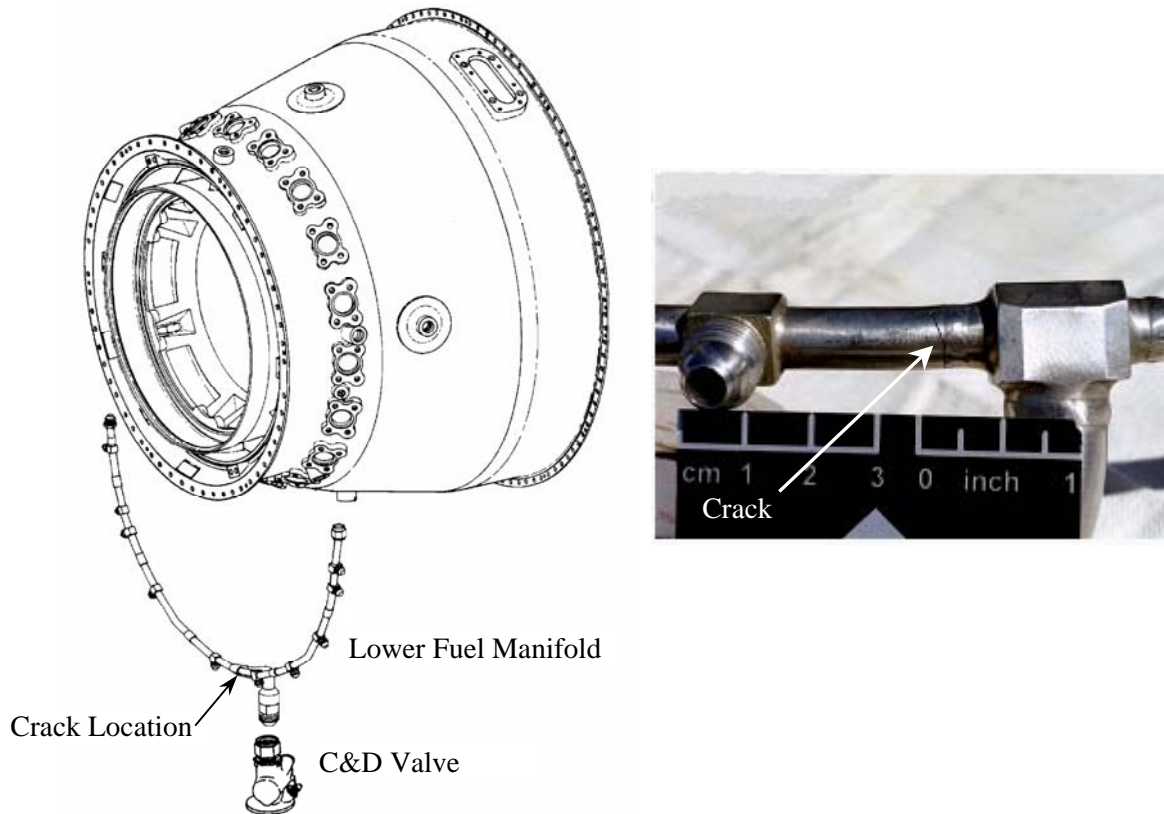
Figure 1: Lower Fuel Manifold

The LFM, shown below in Figure 1, is a semi-circular tube encompassing the lower half of the Combustor Case. The LFM carries pressurized fuel to the fuel nozzles of the engine where it is then mixed with compressed air and ignited within the Combustor Case. Incoming fuel is fed to the LFM via an inlet tube located at the 6 o'clock location of the assembly. Fuel is then split between the left and right sides of the Combustor Case at a welded T-junction in the LFM. The incident assembly described above was found to be cracked in the heat affected zone of one of the three welds at this T-junction.

The cracked LFM was removed from the incident engine and forwarded to GEAE for investigation. Although no manufacturing or design defects were found to explain the cracking, fracture surface analysis indicated that the LFM cracked due to High Cycle Fatigue (HCF). GEAE's conclusions suggested that assembly stresses may have led to the fatigue cracking (since this LFM was not the original component).

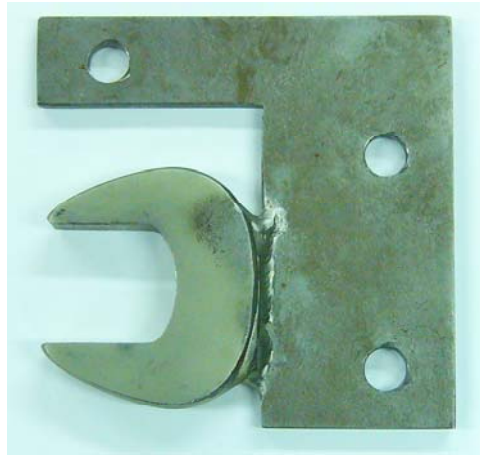
Figure 2: Lower Fuel Manifold Restraining Tool

The LFM is affixed to the Combustor Case using simple bracket assemblies at seven separate locations. During engine assembly, a Check & Drain (C&D) Valve is threaded onto the lower inlet tube of the LFM and a torque of approximately 1000 lb-in is applied. Although a wrench flat on the LFM fitting allows the inlet tube to be restrained during torquing of the C&D Valve, technicians found it difficult to prevent the LFM from twisting, even when two technicians were performing the operation. Therefore, the potential transmission of significant stresses to the LFM inlet tube (and consequently to the LFM T-junction) during engine assembly became the focal point of the investigation.

As a result, a specialized tool was developed to aid in reducing the stresses experienced by the LFM during torquing of the C&D Valve. The tool was designed to be firmly attached to the engine using existing bolt holes while simultaneously restraining the LFM inlet tube from being twisted. Figure 2 illustrates the tool that was developed.

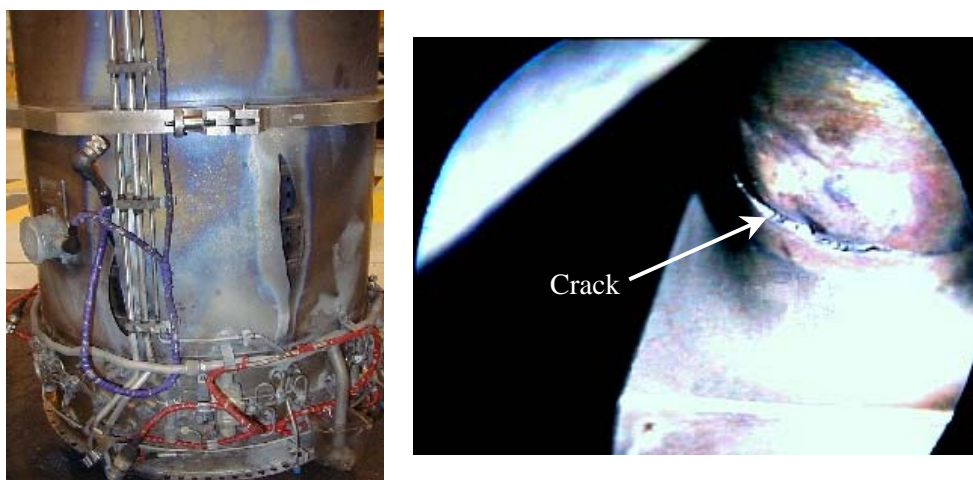
Figure 3: Damaged Engine and Cracked Lower Fuel Manifold

Shortly after takeoff from CFB Cold Lake in August 2001, and after reselecting a throttle setting of maximum afterburner, a CF-18 pilot received audible cautions for a left engine fire. The pilot activated the left engine bay fire suppression system and shut down the incident engine before carrying out a single engine landing without further incident. A preliminary survey revealed multiple ruptures in the afterburner case of the incident engine, through which hot gases escaped, causing significant damage to the airframe. Internal inspection of the incident engine using remote visual inspection equipment revealed a crack in the T-junction of the main LFM. It was concluded that fuel leaking from the cracked LFM was ignited when the pilot advanced the throttles into afterburner operation. Figure 3 depicts damage to the incident engine as well as the cracked LFM.

The engine was removed from its airframe and forwarded to Magellan Aerospace where a controlled disassembly was carried out, documenting the condition of all pertinent hardware and ultimately confirming the cracked LFM. An extensive review of all recorded engine parameters during the incident flight was also carried out in order to gain a better understanding of how the engine performed while being starved of fuel as a result of the cracked LFM. Shortly thereafter, GEAE confirmed HCF to be the mechanism that caused this second LFM cracking event and subsequently recommended that all F404 users take the necessary steps to increase the inspection frequency of all installed LFMs.

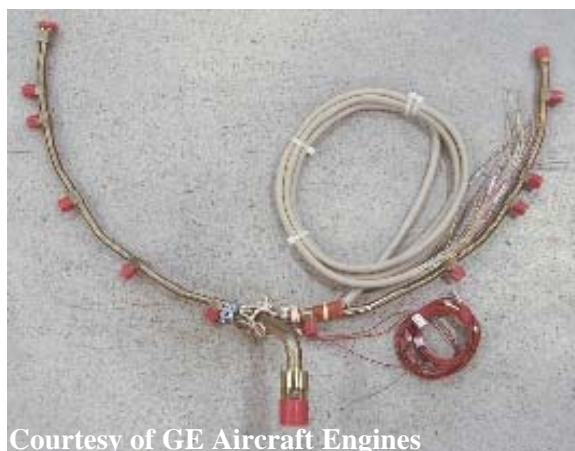
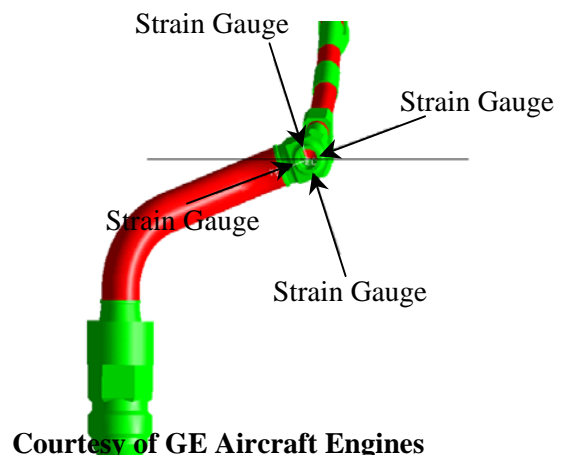
Figure 4: Instrumented Lower Fuel Manifold

An instrumented LFM was provided by GEAE for the engine test. The tube assembly was equipped with eight strain gauges, four on either side of the T-junction, at evenly spaced intervals around the tube circumference as shown in Figure 4.

During installation of the instrumented LFM, static strain gauge readings were taken before and after each step of the build-up, not only to quantify installation stresses, but also to ensure that all gauges continued to function normally. Unfortunately, during the installation, one of the strain gauges stopped functioning and several other gauges reported strains suggesting that the LFM material had been stressed beyond the yield strength, which was highly suspect. Because it was unclear whether these readings were accurate, concerns were raised regarding the integrity of the LFM and the possibility of an in-flight fuel leak during flight tests. In addition, beginning the operational testing of the engine with strain gauges that were already reporting unexpected readings would devalue the entire flight test program. As a result, the instrumented manifold was removed from the engine, and a second instrumented manifold was installed. No unusual strain measurements were reported during the second LFM installation, and all gauges continued to function normally. Unfortunately, this unexpected hardware replacement required a considerable amount of time to correct and highlights the sensitivity of carrying out such an experiment in the field.

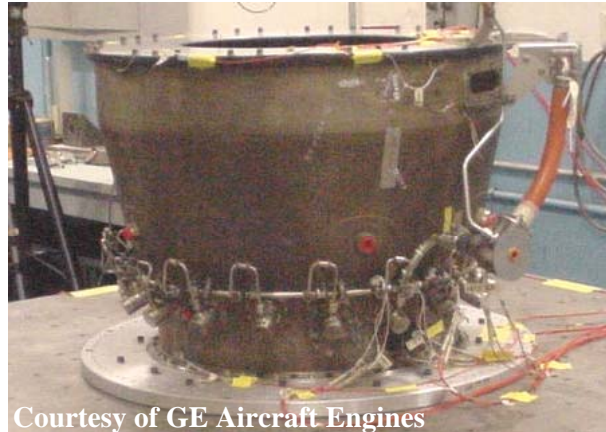
Figure 5: Shake Table Testing Set-up

conditions to facilitate evaluation of mitigation options. An instrumented LFM was installed on a Combustor Case with all pertinent hardware as well as simulated interaction between the C&D Valve and the airframe. This apparatus was oscillated in three planes through a 0 – 2000 Hz frequency sweep while measuring the strain induced in the LFM. Figure 5 depicts the shake table testing set-up.

The frequency sweep identified the first seven resonant modes of the installed LFM, with the first and lowest frequency mode nearly identical to the frequency at which the highest LFM strain level was measured during flight tests. This comparison allowed GEAE to use the shake table to accurately reproduce the strain conditions experienced by an LFM during engine operation with excellent correlation. An LFM endurance test was carried out with oscillations at moderate amplitude (approximately 65% of the design maximum allowable strain at the LFM T-junction) within the low frequency range of interest identified during both the flight tests and the frequency sweep tests. The endurance manifold eventually failed in nearly identical fashion to those that were discovered cracked in service, which not only validated the laboratory set-up, but also provided a baseline against which any mitigation options could be tested.

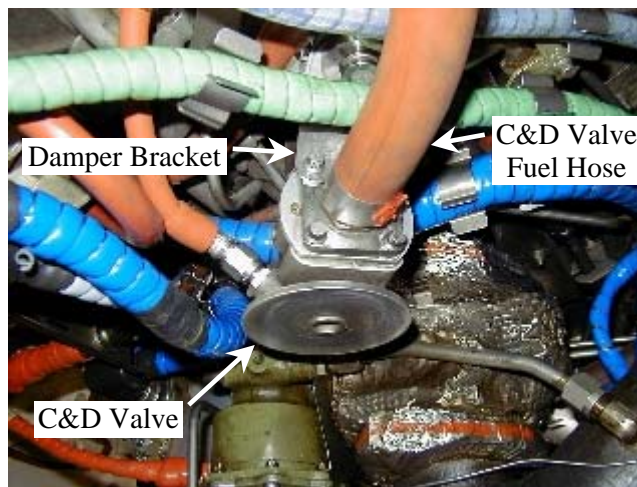
Figure 7: Second Damper Bracket Design

variability in the position of the C&D Valve with respect to the OBD meant that the mounting points for the two damper bracket halves could be of varying distances apart. This created a condition where the two bracket halves would become slightly separated, leaving a small gap between the two halves, and creating an undesirable possibility for abnormal wear of the damper bracket as well as the possibility of compromised dampening effect. This necessitated a redesign of the damper bracket in order to incorporate some adjustability that would allow the bracket to be adaptable to the varying installation conditions on all F404 engines. By May of 2003, a newly designed bracket had been produced by GEAE, which incorporated a feature that would allow the length of one half of the damper bracket to be adjusted in order to span the varying distance between the mounting points on the C&D Valve and the OBD. Figure 7 is a photo of an installed damper bracket, conveying the challenge of incorporating a new component within the complex network of existing engine hardware.

Trial installations were carried out on an F404 engine using the newly designed damper bracket with no further complications. The adjustable feature of the new bracket allowed the system to compensate for the variability of mounting point positions between engines and allowed proper installation of the bracket with little increase in complexity or effort. The new bracket was forwarded to CFB Cold Lake in July 2003 in preparation for flight tests at AETE during the following month. Before testing the new damper bracket, baseline flight tests were performed without the bracket installed in order to re-establish the measured strain levels experienced by the LFM in flight and to ensure that the results had not changed significantly from those recorded during the June 2002 flights. The same test matrix was flown as during the previous flight test phase, however this time only JP8 fuel was used. Upon completion of the baseline flight tests, the recorded data was analyzed and found to be very similar to that recorded during the June 2002 flight tests. The damper bracket was then installed and the flight test matrix was repeated.

Analysis of the damper bracket flight test data was completed in September 2003 with the results indicating that with the damper bracket installed, overall strain levels at the LFM T-junction were reduced by approximately 48%, well below design maximum allowable levels. The damper bracket was found to be extremely effective in mitigating vibration input to the LFM in the low frequency range of concern that was identified during the 2002 flight tests. Based on these results, all parties involved in the development of the damper bracket agreed that the flight tested design was sufficient in its ability to mitigate undesired strain levels in the LFM T-junction and reduce the risk level associated with this issue to an acceptable level.
